NATIONAL ADVISORY COMMITTEE FOR AERONAUTICS

No. 1836

INITIAL INVESTIGATION OF CARBIDE-TYPE CERAMAL OF
80-PERCENT TITANIUM CARBIDE PLUS 20-PERCENT
COBALT FOR USE AS GAS-TURBINE-BLADE MATERIAL

By Charles A. Hoffman, G. Mervin Ault, and James J. Gangler

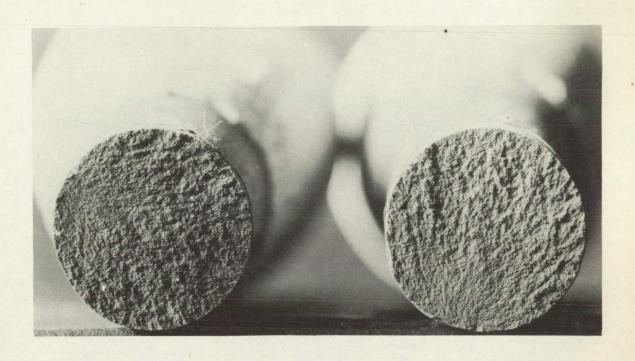
commonly used. These alloys have a short-time tensile strength as great as 37,800 pounds per square inch for alloy 422-19 at 1800° F as indicated in reference 9. In general, the short-time tensile strength for high-temperature alloys is about 33,000 pounds per square inch at 1800° F. Reference 1 indicates that National Bureau of Standards Body 4811 has a short-time tensile strength of 19,000 pounds per square inch at 1800° F. At 2200° F, there are few short-time tensile data for the metal alloys or for ceramics with which the ceramal tensile strengths of 8900 and 13,200 pounds per square inch compared. This value can be considered good at temperatures approaching the melting points of metal alloys. Figure 8 shows specimen 3D5 after failure and illustrates a fracture typical of a brittle material.

Figure 8. - Fractured surface of ceramal tensile specimen 3D5. Tensile strength, 34,600 pounds per square inch at 1800° F.

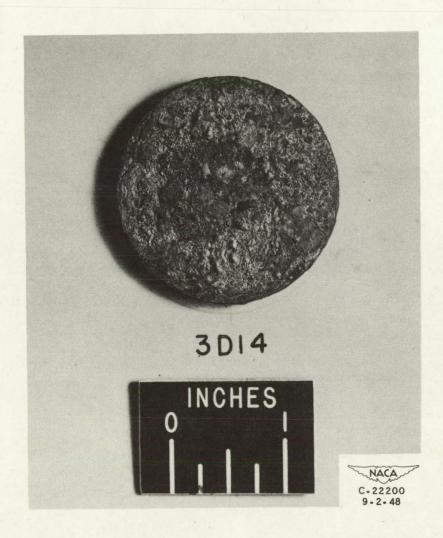
During the thermal-shock investigation, severity of oxidation of the ceramal specimens increased as evaluation temperatures progressed from 1800° to 2400° F. Upon completion of 25 cycles at 1800° F, a relatively thin, tight film was noted. Upon completion of the 25 cycles at 2400° F, the film had become scaly and more

extensive, as indicated in figure 9. Apparently, a difference in coefficients of expansion of the film and of the base material together with the more severe thermal gradients at the higher temperatures cracked the film and exposed new surfaces to exidation, resulting in this appearance. The film thickness at this time was determined as approximately 0.027 inch.

Figure 9. - Ceramal thermal-shock specimen after completion of 25 cycles at 1800° , 25 at 2000° , and 25 at 2400° F.

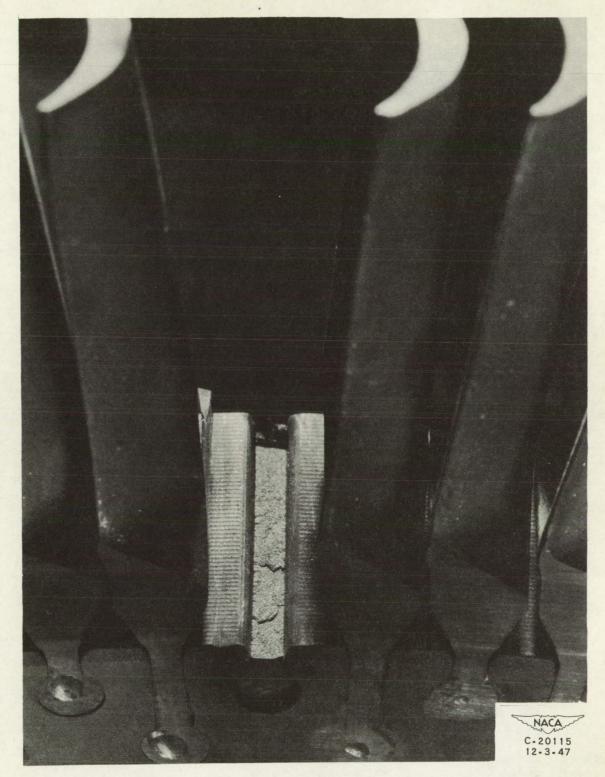
- Phase 1. The results obtained in phase 1 are presented in table III, which shows that during this phase of the evaluation, one ceramal blade failed after 10 minutes of operation at 17,500 rpm and an indicated inlet gas temperature of 2000° F. The total time of operation was 4 hours and 40 minutes under the various conditions noted in table III. The remaining two ceramal blades used in phase 1 fractured within an additional 5 minutes of operation at the same conditions. Examination of the failures indicated that the blades fractured in the neck-roll junction at a point of possible stress concentration caused by the presence of both peening and an abrupt change in root configuration (fig. 10). During overhaul, after failure of the first ceramal blade, minute cracking was noted on the back side of one of the other ceramal blades at the neck-roll junc-This occurrence might reasonably have been the result of stress concentration. These three failures may also have been largely the result of

- (1) operation at a shaft speed (17,500 rpm) that may have caused resonant vibration of the blade to occur
- (2) peening stresses, in addition to the stresses existing at operating conditions at time of fracture, exceeding the strength of the material.

Figure 10. - Typical fracture of ceramal blade experienced during phase 1 of quasi-service evaluation.

- Phase 2. The roots of a second set of three ceramal blades were copper-plated and then so installed as to permit redistribution of load and minimizing of stress-concentration effects. Copper was selected as a plating in order to preserve the full advantage of the excellent thermal conductivity of the ceramal (20.56 Btu/(hr)(sq ft) (°F/ft) at room temperature, reference 2). The metal blades had a substantially lower thermal conductivity (8.38 Btu/(hr)(sq ft)(°F/ft) at 392° F). The high thermal conductivity of the ceramal blade material was expected to result in lower operating temperatures for these blades and would increase operating temperatures of the disk rim by heat conduction to the disk. Of the 139 metal blades, 127 were original blades from phase 1, and 12 were new blades installed as control blades. The operation program was modified to eliminate wheel operation at or near 17,500 rpm.

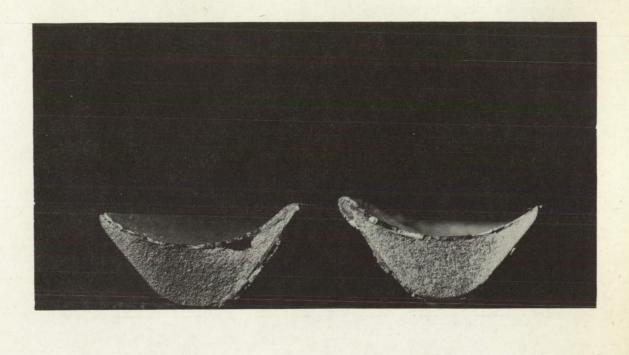
The results obtained in phase 2 of this evaluation with the second set of ceramal blades are indicated in table IV, which shows that 12 hours and 13 minutes of operation were completed. At the end of this time, service failure had taken place in 96 metal blades from phase 1 of this investigation, 8 control blades (a ninth blade had begun to crack), 4 replacement, and 1 ceramal blade. Of the three ceramal blades, only one can be considered a service failure. One ceramal blade, which was inadvertently fractured during overhaul after 9 hours and 42 minutes of operation, is shown in figure 11 in which a two-layered oxide film is apparent. The fracture of this blade during routine wheel handling is indicative of the need for special care in the handling of bodies fabricated of materials of this type.

Figure 11. - Ceramal blade inadvertently fractured after 9 hours and 42 minutes of operation.

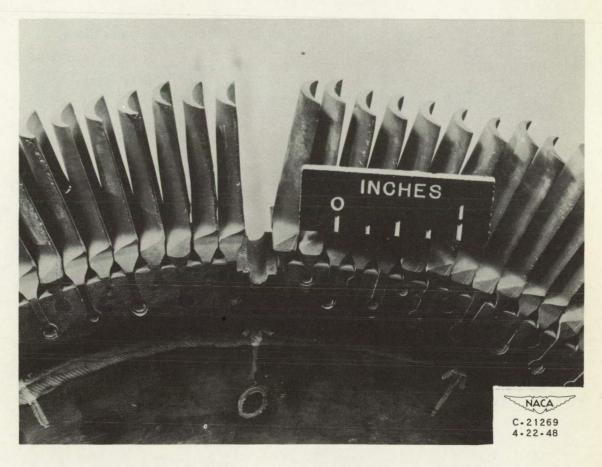
A second ceramal blade (fig. 12(a)) was destroyed after 12 hours and 13 minutes of operation because of wheel-dovetail failure that allowed the blade to fly loose. A study of figure 12(b) indicates distortion of disk material about the failed dovetail 33 minutes before failure. The ceramal blades were not removed to other positions because they were held very tightly and blade injury might result through moving. Enlargement of the dovetail roll, peening, and local heating of the disk because of the high thermal conductivity of the ceramal blade material undoubtedly resulted in a stress-temperature condition that caused fracture of the dovetail. The third ceramal blade apparently fractured as a result of factors normally operating to induce blade failure (fig. 13(a)), although the blade fractured simultaneously with the disk-dovetail failure.

(a) Close-up of failure after 12 hours and 13 minutes of operation.
Figure 12. - Disk-dovetail failure.

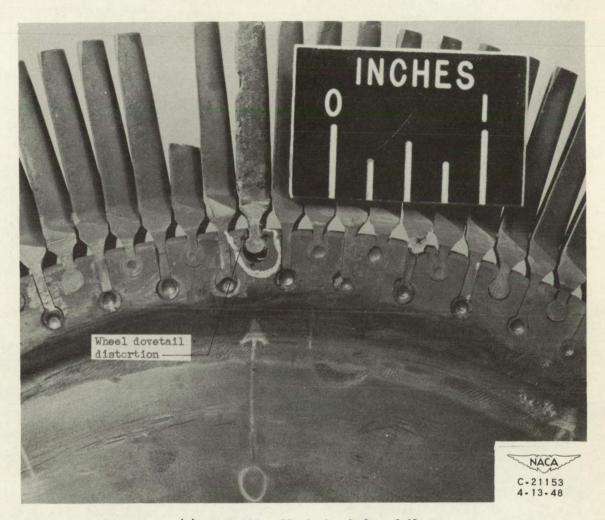
During the course of operation, the copper flowed from the ceramal blade roots, which is also indicated in figure 12(b). This condition was noted shortly after the wheel was put into operation. The greater part of phase 2 of this investigation was conducted with the ceramal blades retained in the manner indicated. A thin layer of copper remained fused to the blades and to the wheel dovetail, retaining the blades in place. Stress at the root neck-roll junction was relieved. A ceramal blade (fig. 12(b)) was nicked; this nick occurred during run 3 and was caused either by a flying blade fragment or by foreign matter in the inlet gas.

(b) Distortion 33 minutes before failure.

Figure 12. - Concluded. Disk-dovetail failure.

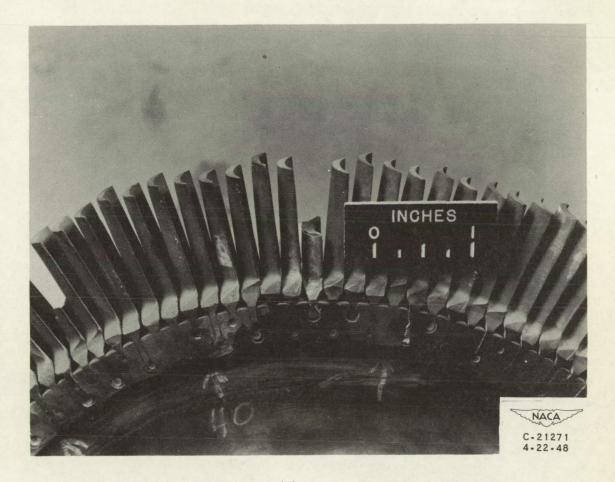
(a) Close-up of failure.

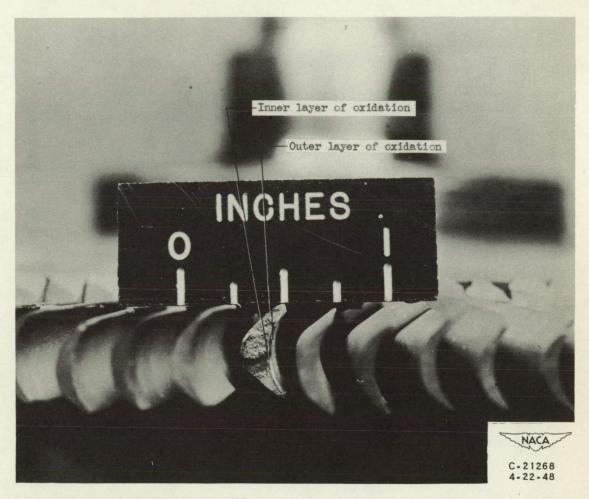
The fracture surface of the service-failed ceramal blade after 12 hours and 13 minutes of operation is shown in figure 13(b). A two-layered oxide film is in evidence. This film was found to be of different thickness on the leading and trailing edges of the blade, which might be indicative of the temperatures at those areas. The film thicknesses for this blade and for the blade inadvertently fractured after 9 hours and 42 minutes of operation are given in the following table:

These measurements were taken by use of a microscope fitted with a filar eyepiece, with the fractured surface of a blade viewed through the eyepiece. The scale was tenacious and showed no tendency to flake off during turbine operation. This type scale would tend to preserve aerodynamic shape and to minimize the risk of flying scale damaging sound blades. Expedients such as ceramic coating may be found necessary to minimize oxidation for long periods of operation. No appreciable elongation of the ceramal blades occurred.

(b) Fractured surface.

Figure 13. - Concluded. Ceramal-blade failure after 12 hours and 13 minutes of operation.
